**50° CONSTANT VELOCITY JOINT
OVER ANGLE**

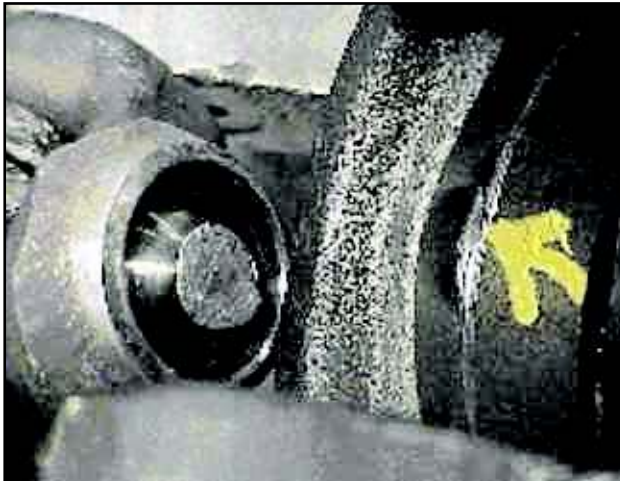
CENTER HOUSING

These pictures show damage resulting from contact of the ball and socket with the center housing when operating a 50° constant velocity (CV) joint beyond the 50° design limit. If contact occurs when the driveline is not turning, the center housing will be dented as shown, and the ball may separate. If contact occurs while the driveline is turning, the center housing will have a longer contact area in the same location as the non-operating dent, and the ball may separate.
