**Weasler®**

**80° CONSTANT VELOCITY JOINT  
OVER ANGLE OPERATING**

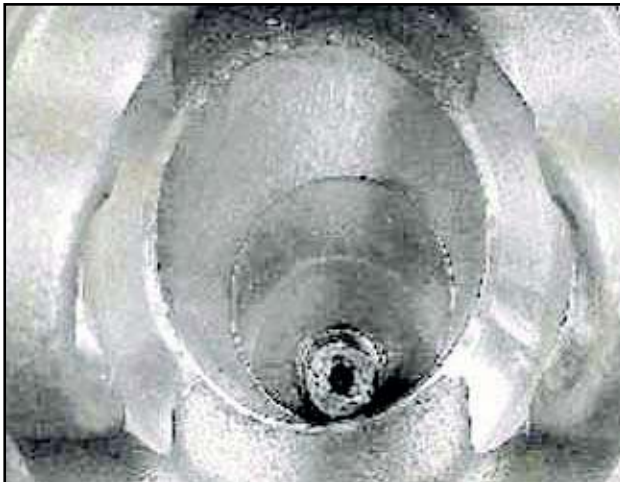
**SIDE 1**

These pictures show damage resulting from turning an 80° CV joint beyond the 80° design limit while the driveline is operating. Both sides of the same center housing are shown. On side 1 the pin has sheared. On side 2 the pin remains intact but the center housing shows chatter marks from over-angle. This ball and socket yoke has a missing ball, while the retaining ring has been stretched and cracked.
